FLOOD PROTECTION EXPERIENCES ON THE DRAVA RIVER BASIN IN CROATIA

Maribor, September 23-25 2008

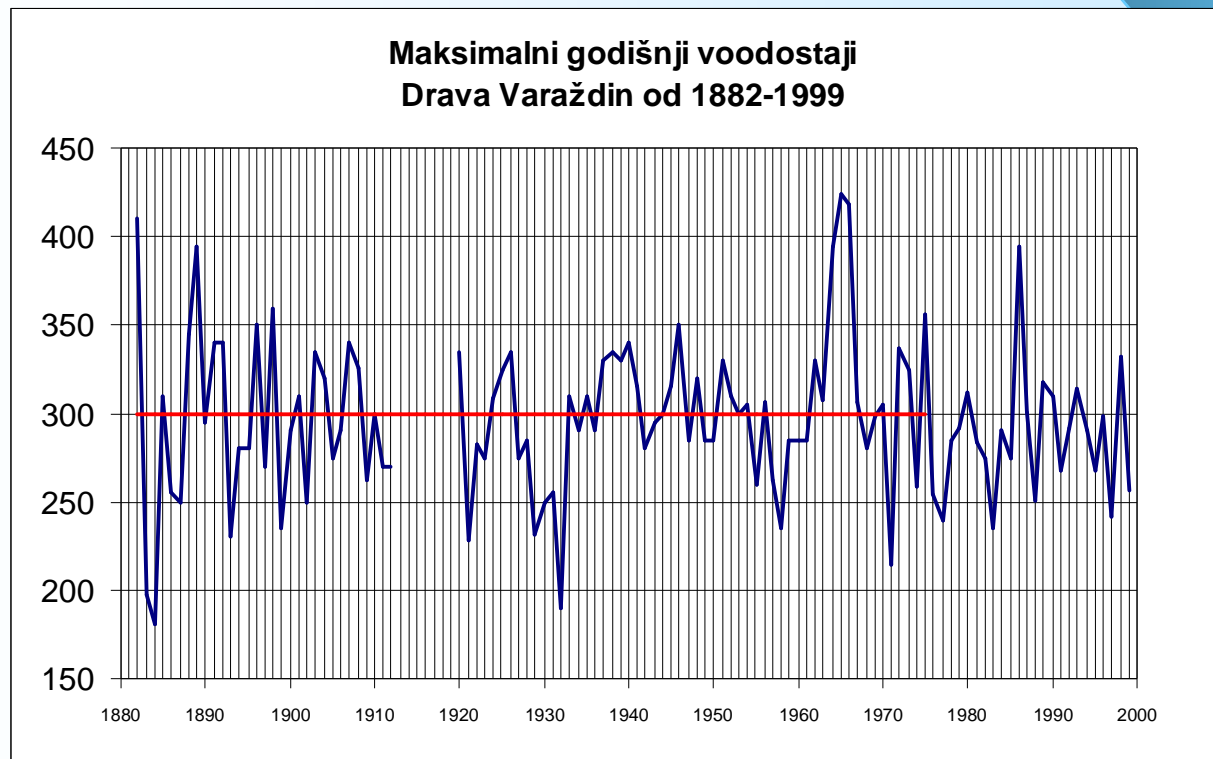
20th century floods on Drava river

- | In 20th century 54 high water levels were recorded
- | The largest flooding: 1926, 1954, 1965 and 1972

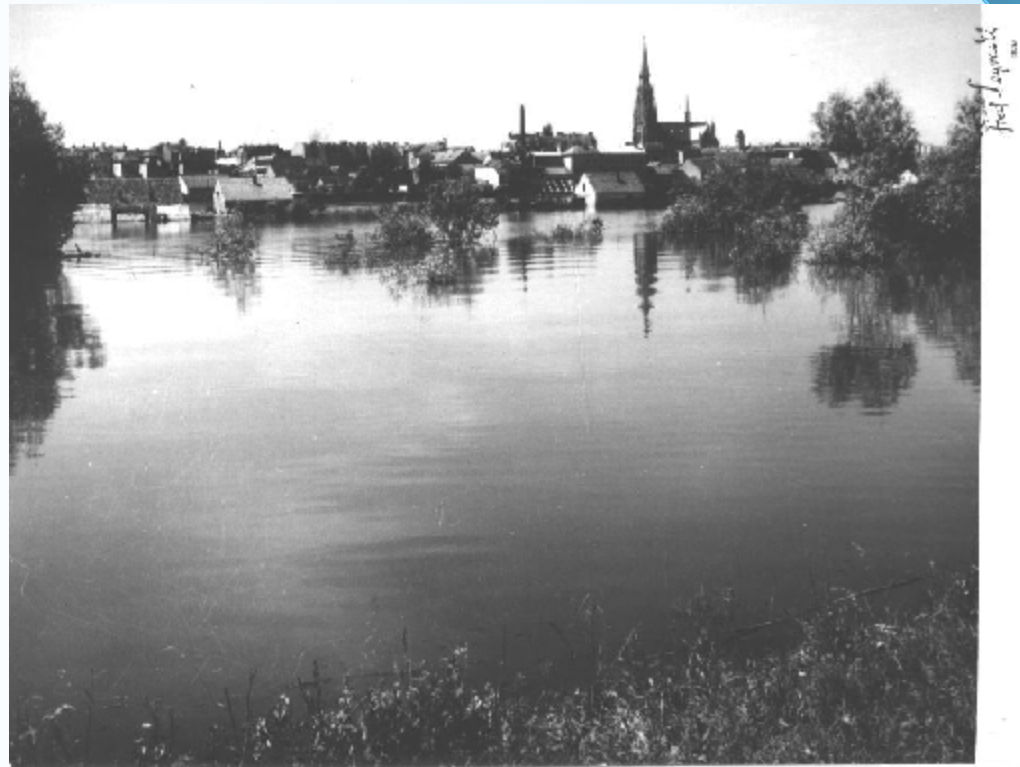
Floods on Drava and Danube in 1965

- | The emergency flood protection measures was declared on 21th May 1965, but already on 25th June 1965. Drava river near to Osijek and Danube river near to Vukovar caught absolute water level maximum at +542 cm (caused by small surge capacity of the Danube river), respectively + 766 cm which is valid up now

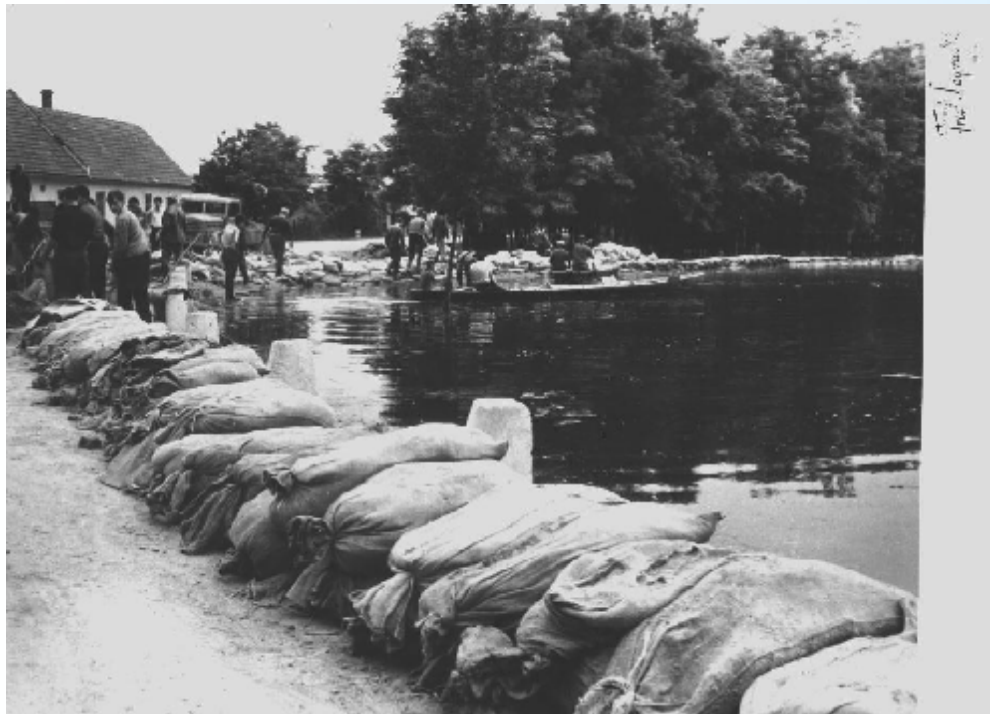
Floods on Drava and Danube rivers in 1965

- Despite huge human efforts lot of dyke breaches occurred

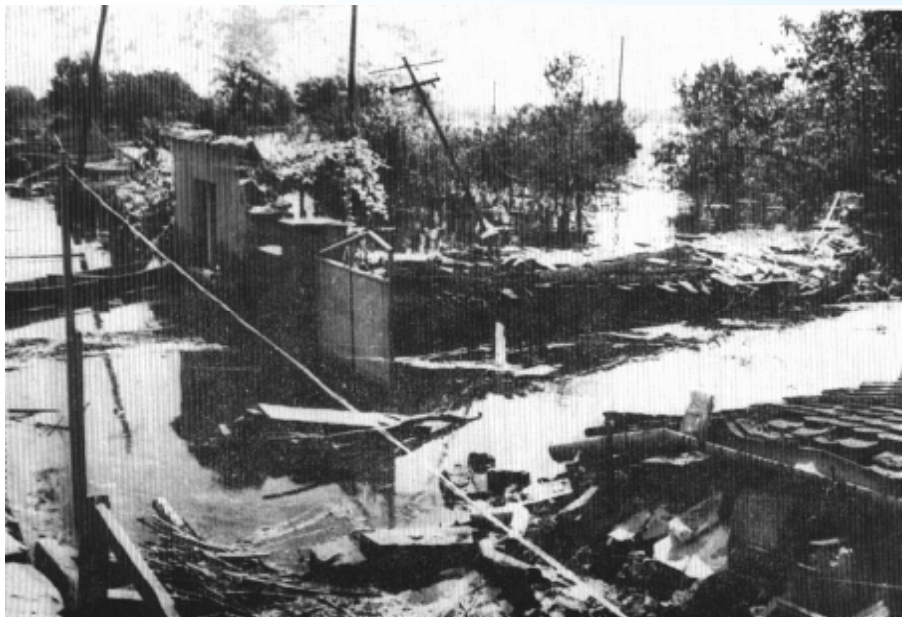
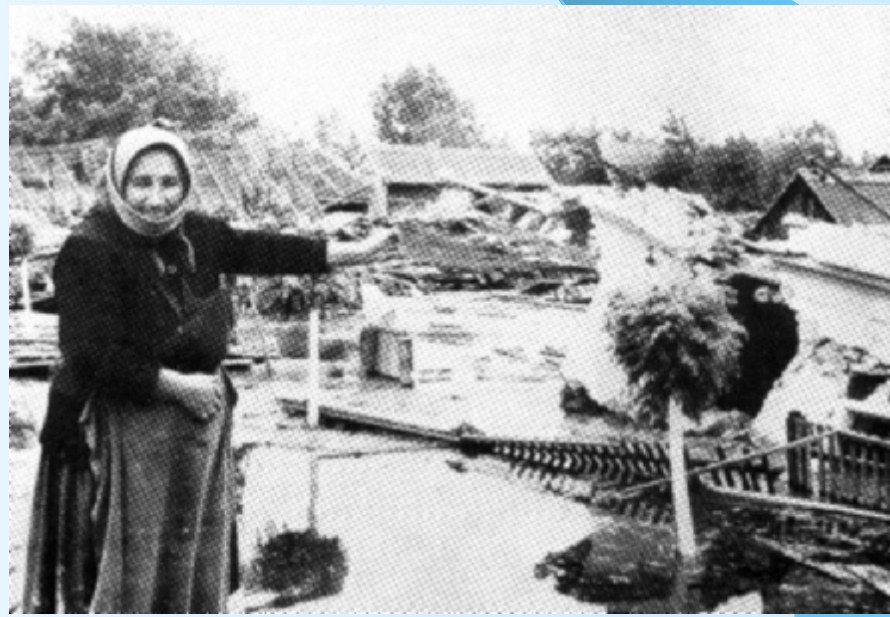
Floods on Drava and Danube rivers in 1965

- | The consequences of flood (duration: 105 days)
 - | 82 settlements with 35,000 habitants were endangered
 - | Flooded 3,448 apartment buildings (1,371 facility was crumbled)
 - | 16 km of sewage network was destroyed, 42 km of water supplies network and roads in length of 52 km
 - | Without human casualties

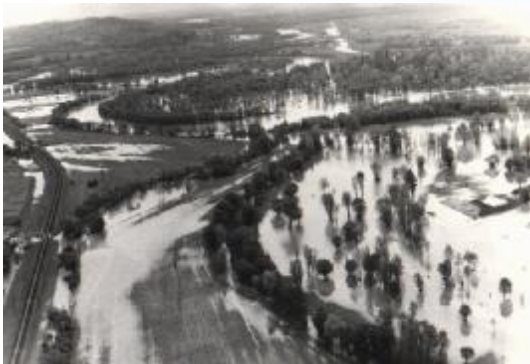
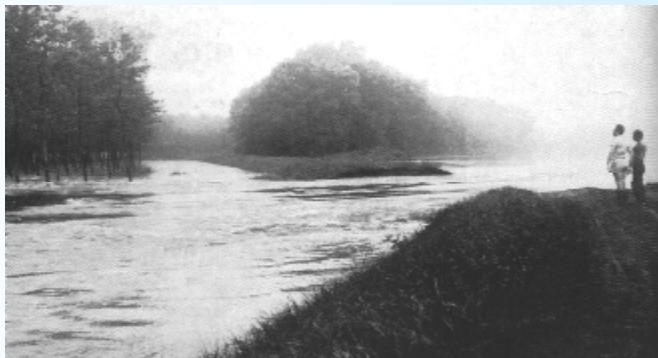
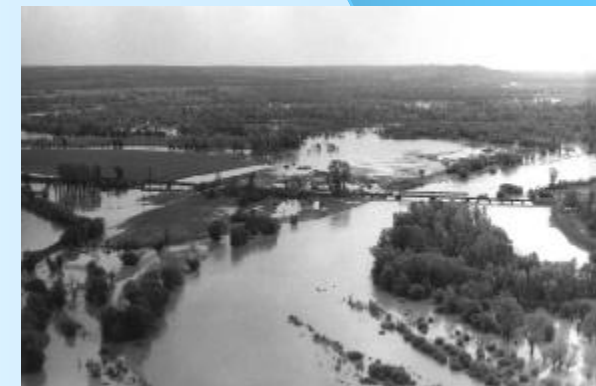
Floods on the Drava river in July 1972

- | With its dimension and damages the floods exceed the catastrophic one from 1965
- | The whole water district from Varaždin town to Osijek town was endangered again with numerous dyke breaches on four locations
- | Maximum water level were recorded on Drava river gauging stations (valid up to now)

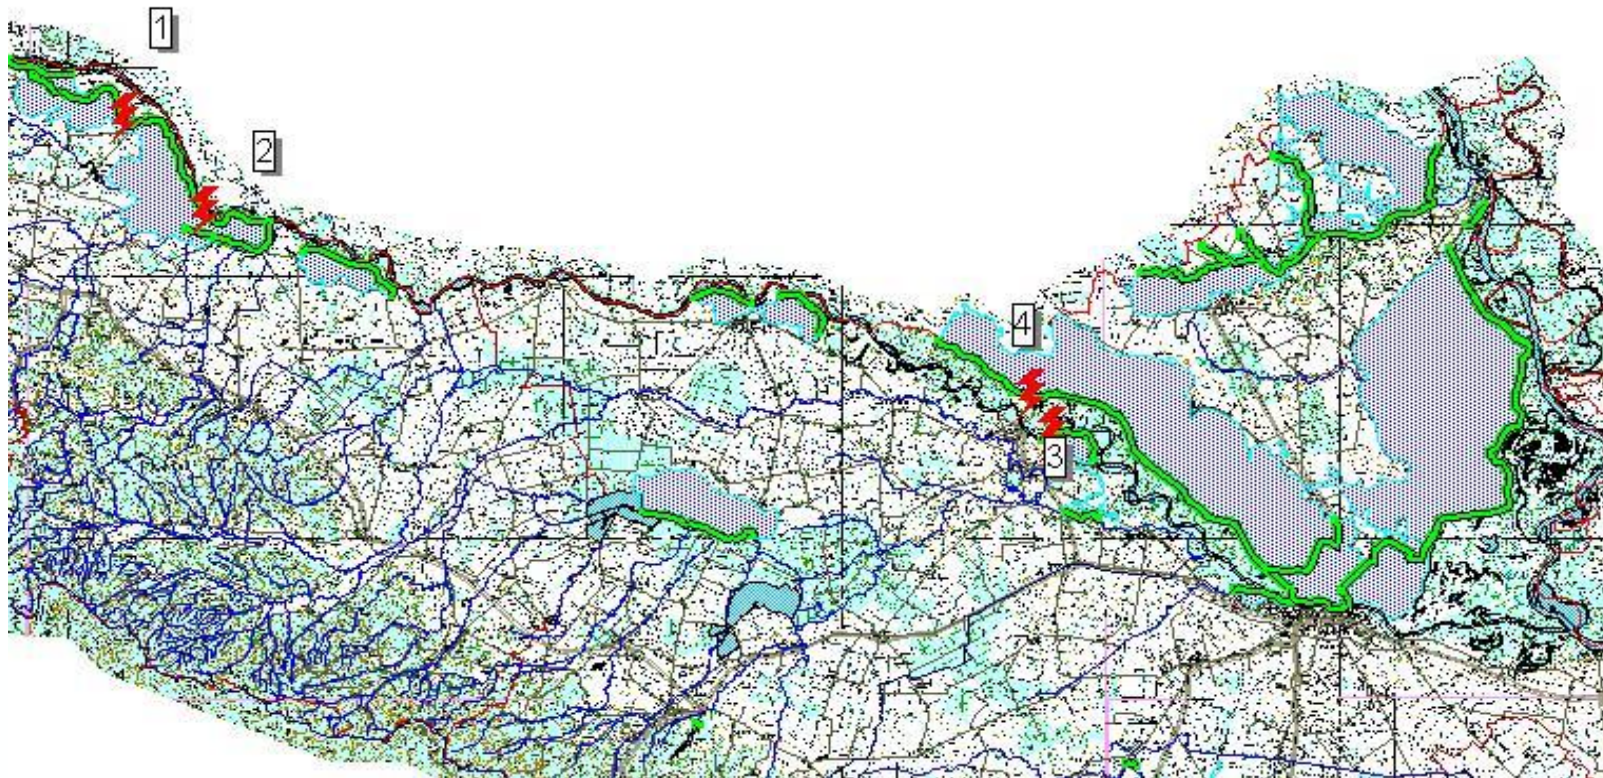
Floods on the Drava river in July 1972

- Despite on facts that on flood protection more then 30,000 people were involved, the great damages were not avoided but fortunately without human casualties
- Slavonian and Baranian fields are turned into vast lakes, but the highest destructions flood made on areas of Beli Manastir and Slatina
